Precision Hydrodemolition

Hunterston Nuclear Power Station Cooling Water Intake Structure – Jetty

Client: EDF Energy

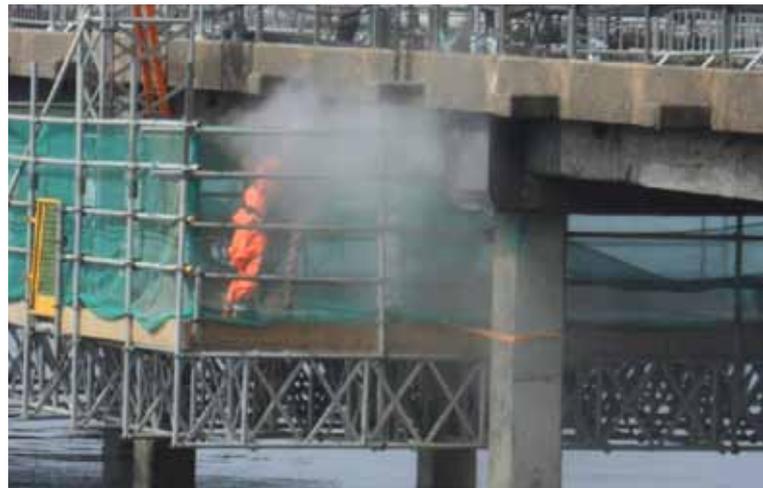
phase was to remove the failed bitumen protective coating from concrete surfaces under the structure. Once this had been completed there were about 30 cubic metres of defective concrete to be precision cut and removed using ultra high pressure Hydrodemolition.

RGL proposed an innovative technical solution which employed a low flow ultra high pressure water jet. By increasing the pressure up to 2,500bar it enabled RGL to halve the water flow required. This resulted in a manageable and permissible reaction force on the operators. This low reaction force meant that operators suffered less work fatigue and it also reduced the risk of injury and accidents.

Furthermore it enabled the concrete to be cut out with a very high level of accuracy. It was this capability that led to a fundamental change in project scope and method of working.

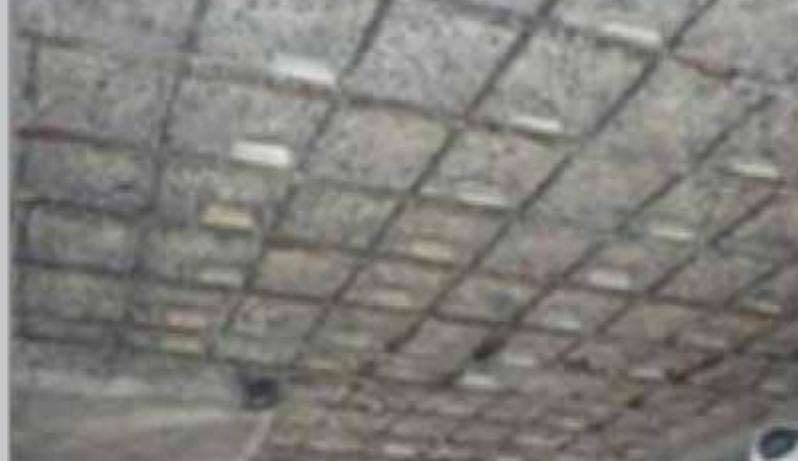
Deck soffit after precision Hydrodemolition and installation of the galvanic anodes

“Very soon after the project start it was quickly realised that instead of removing all the concrete from the bay soffits, it would be more cost effective to precision cut patches of defective concrete. It is essential to cut back behind the first layer of steel reinforcement to ensure maximum strength and integrity of the repair.”

Consequently the project was re-scoped from mass high volume concrete removal to a ‘hit and miss’ repair approach which required a greater level of plant and operative mobility as they switched from one jetty bay to another to help maintain structural strength of the jetty.

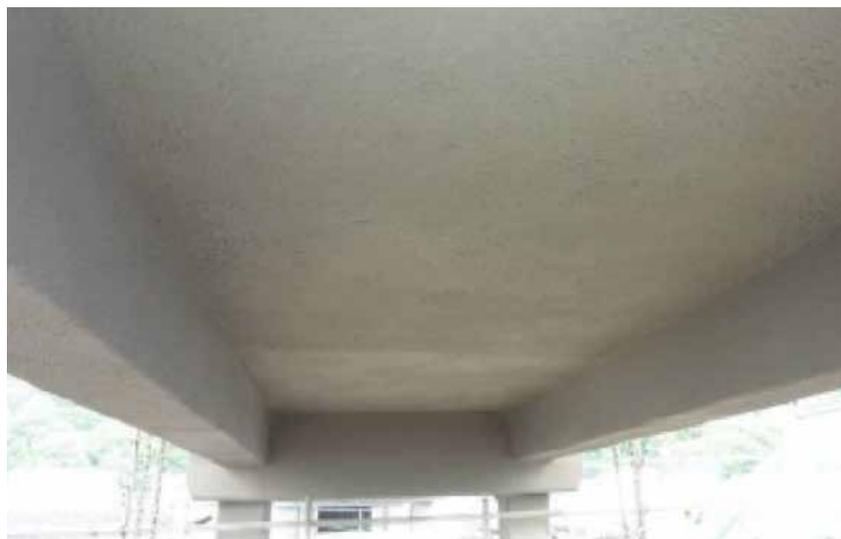
“Finished product”. Deck underside with repairs complete and final flash coat applied
